PHOTOGRAPHIC SURVEY OF THE LDEF MISSION

National Aeronautics and
Space Administration

NASA Special Publication 531
1996

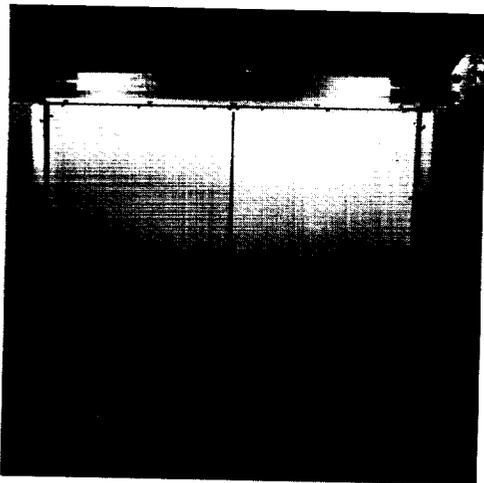
Figure 483
Photo No.: KSC-390C-833.08
Dup. Neg. No.: L90-13367
LISAR No.: EL-1994-00175
Photo Credit: KSC
Photo Date: 2/7/90
Location: KSC SAEF II
Subject: Postflight Survey of Tray F3

Figure 483 (Postflight). The pink and greenish-gray tints on the two debris panels are by-products of the chromic anodize coating process and are not attributed to contamination or exposure to the space environment. The light band along the sides and across the bottom of the panels is caused by light reflecting from the tray sidewalls.

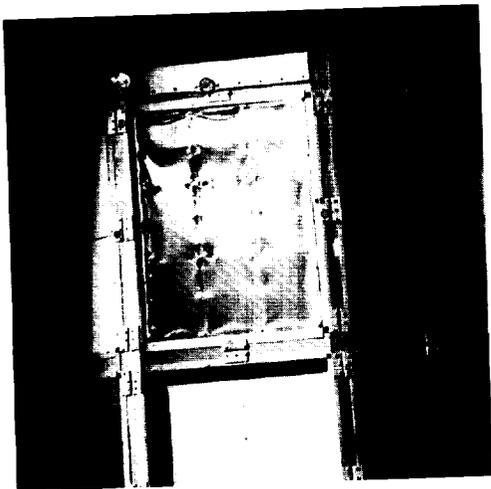
Figure 484 (In Flight). The thermal cover appears to be specular and intact with several small circular areas that appear to be impacts. The cover is more taut than in the prelaunch photograph. The wrinkled spots on the thermal cover are areas where Velcro attachment pads are bonded to the back of the cover. The scalloped effect around the cover edges occurs between the attachment pads. The ground strap is in place and has no visible damage.

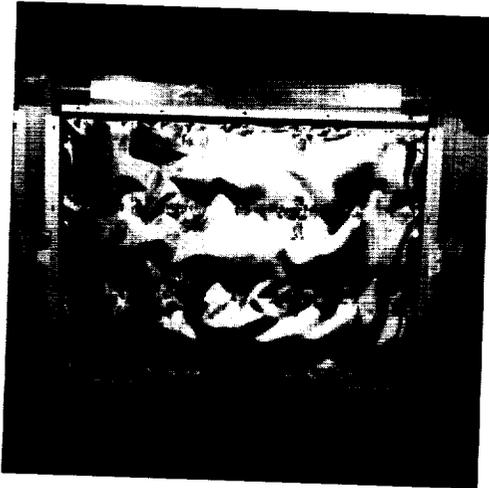
Figure 485
Photo No.: KSC-390C-832.02
Dup. Neg. No.: L90-13349
LISAR No.: EL-1994-00171
Photo Credit: KSC
Photo Date: 2/7/90
Location: KSC SAEF II
Subject: Postflight Survey of Tray F4

Figure 485 (Postflight). The thermal cover appears to be specular and intact. Because of lighting, the locations that appeared to be impacts in the in-flight photograph are not apparent. The thermal cover is less taut than in the in-flight photograph. The wrinkled spots on the thermal cover are areas where Velcro attachment pads are bonded to the back of the cover. The scalloped effect around the cover edges occurs between the attachment pads. The ground strap is in place with no visible damage, but it appears darker.

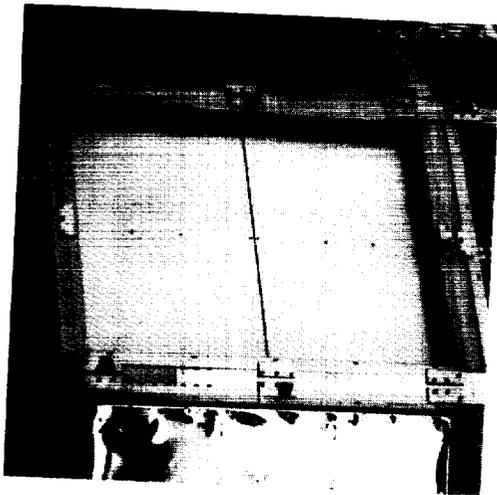
Figure 493 (In Flight). The greenish-gray and pink tints on the two debris panels are by-products of the chromic anodize coating process and are not attributed to contamination or exposure to the space environment. Fingerprints along the center edges of the debris panels indicate improper preflight handling and cleaning.

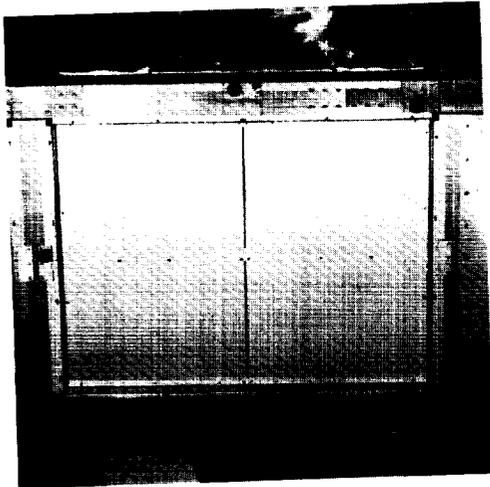
Figure 494
Photo No.: KSC-390C-1035.04
Dup. Neg. No.: L90-13449
LISAR No.: EL-1994-00182
Photo Credit: KSC
Photo Date: 2/9/90
Location: KSC SAEF II
Subject: Postflight Survey of Tray F5

Figure 494 (Postflight). The greenish-gray and pink tints on the two debris panels are by-products of the chromic anodize coating process and are not attributed to contamination or exposure to the space environment. The fingerprints along the center edges of the debris panels that were observed in the in-flight photograph are still visible. The light band across the bottom of the panels is caused by light reflecting from the tray sidewalls.

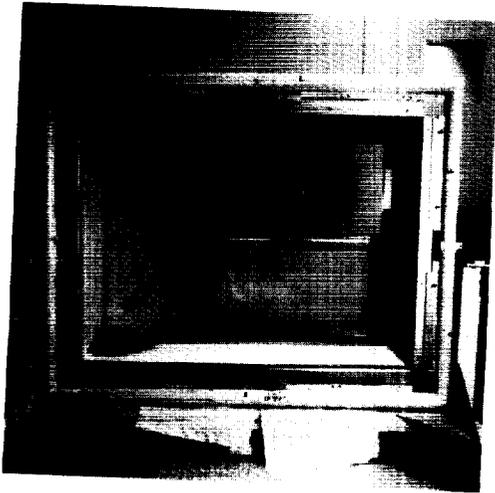
Figure 498
Photo No.: KSC-390C-1563.06
Dup. Neg. No.: L91-11327
LISAR No.: EL-1994-00291
Photo Credit: KSC
Photo Date: 3/5/90
Location: KSC SAEF II
Subject: Postflight Detail of Tray F6

Figure 498 (Postflight). This photograph is of the tray with one of the photographic lights turned off. The brown discoloration is uniform over the tray bottom; however, there is a heavier concentration on the lower left tray wall.

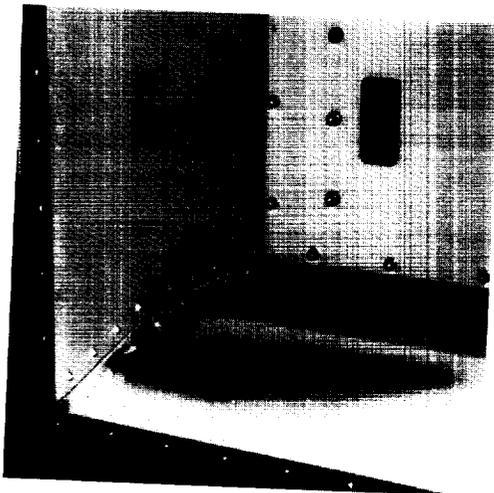
Figure 499
Photo No.: KSC-390C-1564.11
Dup. Neg. No.: L91-11343
LISAR No.: EL-1994-00292
Photo Credit: KSC
Photo Date: 3/5/90
Location: KSC SAEF II
Subject: Postflight Detail of Lower Left of Tray F6

Figure 499 (Postflight). This close-up photograph is of the lower left corner of the tray. There is an area of concentrated brown discoloration on the lower tray wall.

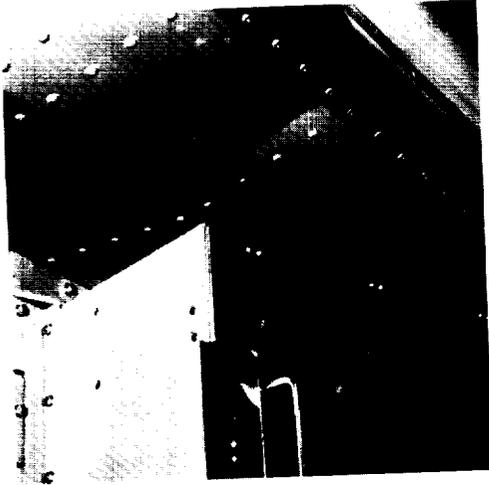
Figure 500
Photo No.: KSC-390C-1565.01
Dup. Neg. No.: L91-11344
LISAR No.: EL-1994-00293
Photo Credit: KSC
Photo Date: 3/5/90
Location: KSC SAEF II
Subject: Postflight Detail of Upper Left of Tray F6

Figure 500 (Postflight). This close-up photograph is of the upper right side of the canister box. The brown discoloration appears uniform, except there is a well-defined discoloration pattern of the canister on the upper tray wall. The cover was installed on the canister housing to protect the space-exposed hardware.

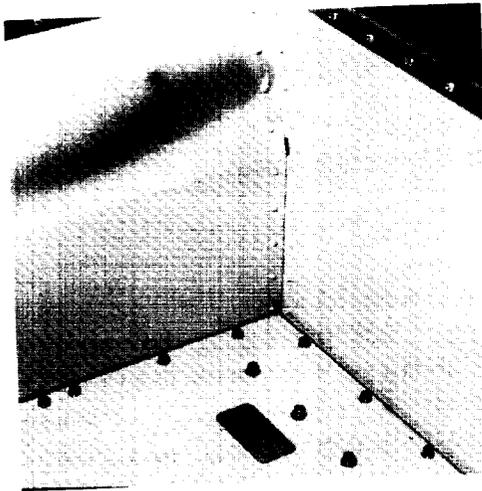
Figure 504
Photo No.: KSC-390C-1565.09
Dup. Neg. No.: L91-11351
LISAR No.: EL-1994-00116
Photo Credit: KSC
Photo Date: 3/5/90
Location: KSC SAEF II
Subject: Postflight Detail of Lower Left Corner of
Tray F6

Figure 504 (Postflight). This close-up photograph of the lower left corner of the tray shows the contrast in amount of discoloration.

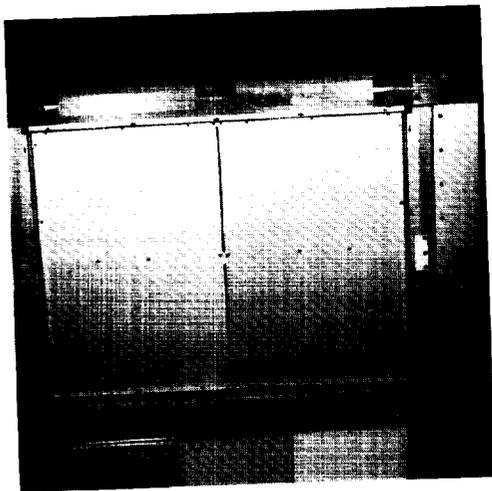
Figure 506
Photo No.: KSC-390C-1032.02
Dup. Neg. No.: L90-13424
LISAR No.: EL-1994-00177
Photo Credit: KSC
Photo Date: 2/9/90
Location: KSC SAEF II
Subject: Postflight Survey of Tray F7

Figure 506 (Postflight). The pink and greenish-gray tints on the two debris panels are by-products of the chromic anodize coating process and are not attributed to contamination or exposure to the space environment. The streaks on the debris panels in the in-flight photographs are almost invisible because the reflection of the sky is not present. The light band along the sides and across the bottom of the panels is caused by light reflecting from the tray sidewalls.

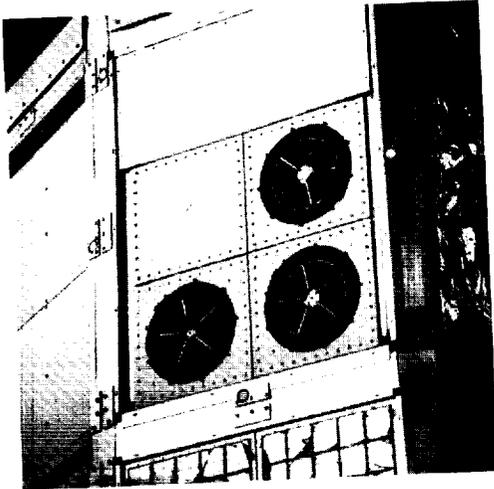
Figure 508
Photo No.: S32-76-020
Dup. Neg. No.: L90-10379
LISAR No.: EL-1994-00664
Photo Credit: JSC
Photo Date: 1/12/90
Location: In Flight
Subject: In-Flight Survey of Tray F8

Figure 508 (In Flight). The coils have changed color. The upper right coil, originally glossy black, now appears to be dark brown. The lower right coil, originally a glossy royal blue, now appears to be navy blue. The two 20-m coils of linked fiber optic cables in the lower left have more extensive color changes. The exterior cable that was originally yellow now appears to be slate gray and the interior cable that was light tan appears to be brown.

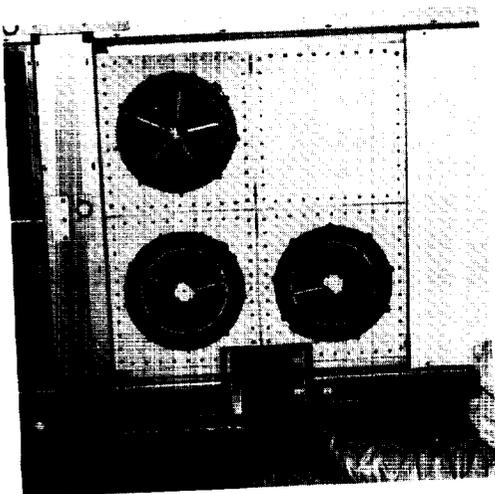
Figure 509
Photo No.: KSC-390C-1145.02
Dup. Neg. No.: L91-15071
LISAR No.: EL-1994-00191
Photo Credit: KSC
Photo Date: 2/18/90
Location: KSC SAEF II
Subject: Postflight Survey of Tray F8

Figure 509 (Postflight). Colors of all three exposed coils of fiber optic cables have changed significantly. The lower right cable, which was originally glossy black, is now dark brown. The lower left cable, which was originally glossy royal blue, is now navy blue. The upper left cable, which was originally yellow and that was slate gray in flight, is now light gray. The cable that was brown in flight is now a lighter brown. The Chemglaze white paint on the large cover plate has maintained the prelaunch color, but the IITRI S13G-LO white paint on the small cover plate has changed to a uniform light tan.

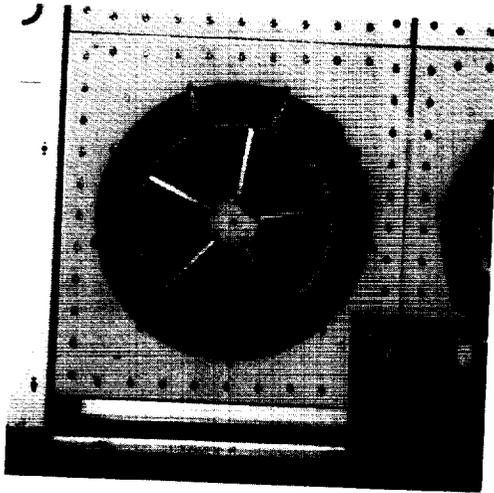
Figure 510
Photo No.: KSC-390C-1145.03
Dup. Neg. No.: L91-15072
LISAR No.: EL-1994-00306
Photo Credit: KSC
Photo Date: 2/18/90
Location: KSC SAEF II
Subject: Postflight Detail of Lower Left Fiber Optic
Coil of Tray F8

Figure 510 (Postflight). This photograph is of the lower left coil of fiber optic cable. The cable was originally a glossy royal blue, but it is now a darker, duller navy blue. The color of the silicone-rubber spacers under the coil attachment clips has changed from clear to brown. The spacers appear to have discolored the cables. Brown discolorations have appeared at the lower left corner of the tray.

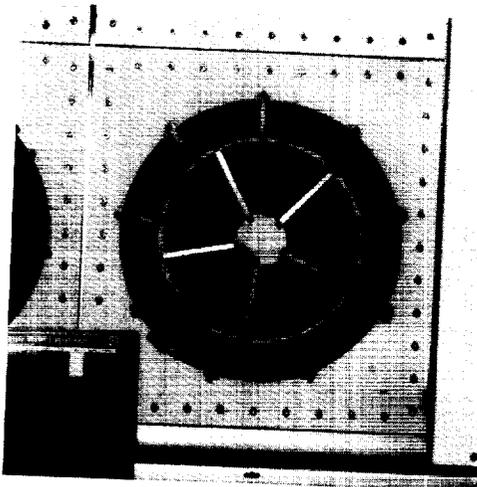
Figure 511
Photo No.: KSC-390C-1145.04
Dup. Neg. No.: L91-15073
LISAR No.: EL-1994-00307
Photo Credit: KSC
Photo Date: 2/18/90
Location: KSC SAEF II
Subject: Postflight Detail of Lower Right Fiber
Optic Coil of Tray F8

Figure 511 (Postflight). This photograph is of the lower right coil of fiber optic cable. The cable that was originally glossy black is now dark brown. The color of the silicone-rubber spacers under the coil attachment clips has changed from clear to brown. The spacers have discolored the cables. There is some discoloration near the lower right corner of the coil mounting plate

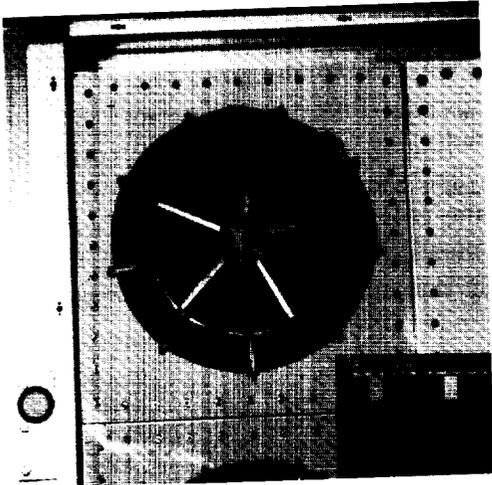
Figure 512 (Postflight). This photograph is of the two 20-m coils of fiber optic cables in the upper left part of the tray. These coils have more extensive color changes than the other coils. The cable that was originally yellow and that was slate gray in the in-flight photograph, is now a light gray. The cable that was brown in the in-flight photograph, now is a lighter brown. The color of the silicone-rubber spacers under the coil attachment clips has changed from clear to brown. The spacers appear to have discolored the cables. There is also discoloration on the mounting plate just above the coils and on the tray at the upper left corner.

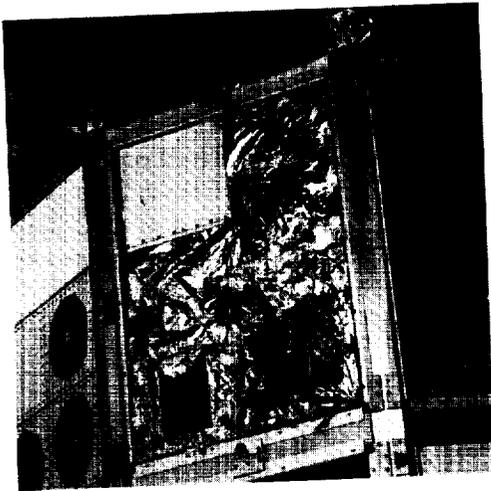
Figure 514
Photo No.: S32-78-087
Dup. Neg. No.: L90-10448
LISAR No.: EL-1994-00020
Photo Credit: JSC
Photo Date: 1/12/90
Location: In Flight
Subject: In-Flight Survey of Tray F9

Figure 514 (In Flight). Aluminum particles from the degraded thermal blanket of experiment AO076 are visible on the upper structure intercostal. There is a line of dark discoloration on this intercostal that was adjacent to the edge of the space end thermal panel. An area underneath the edge of the thermal panel allowed venting of the LDEF interior. The external materials of experiment AO076 have changed significantly. The Kapton film on the thermal blanket appears to be completely eroded, except under the buttons that were used to secure the blanket. The erosion left only a very thin coating of vapor-deposited aluminum as a cover. Aluminum coating residue has covered a portion of the black chrome solar collector and also areas of the upper and lower flanges of the trays. The shadow on the tray lower flange indicates that the aluminum extends several inches beyond the tray. One of two thin-film atomic oxygen experiment patches is gone and the other does not appear to be securely attached. The layer of Kapton tape over the thin-film strips appears to be eroded with only the adhesive remaining. The remaining atomic oxygen experiment materials have changed color and most appear to be severely degraded. The silvered Teflon coating of the radiator panel appears diffuse with a light brown discoloration over most of the surface. The black spots on the radiator panel appear to be impact craters where debris penetrated the Teflon material and exposed the silver beneath to atomic oxygen flux. Particles of the degraded thermal blanket material appear to be adhered to the surface of the radiator panel.

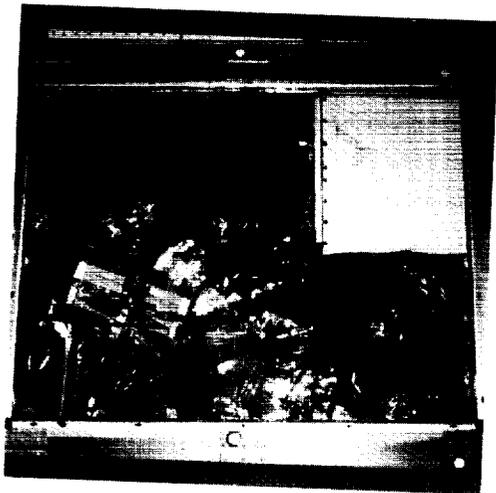
Figure 515
Photo No.: L90-1826
LISAR No.: EL-1994-00354
Photo Credit: LaRC
Photo Date: 3/12/90
Location: KSC SAEF II
Subject: Postflight View of Tray F9

Figure 515 (Postflight). The LDEF structure with the intercostal on the right has a dark brown discoloration that is adjacent to the edge of the space end thermal panel. An area underneath the edge of the thermal panel allows venting of the LDEF interior. Aluminum pieces of the degraded experiment AO076 thermal cover that were lodged in the vent in the in-flight photograph are gone. The external surface of the experiment AO076 has changed dramatically from that observed in the in-flight photograph. The thin coating of vapor-deposited aluminum, which was left after the Kapton film eroded, is essentially gone; only fragments of the coating are left near the edges of the thermal blanket. Pieces of Dacron mesh (bridal veil) material, which was used to separate the thermal cover from the thermal blanket and between sheets of aluminized Kapton film in the thermal blanket, are visible along the edges of the blanket and near the buttons that were used to secure the blanket. A large fragment of the Dacron mesh is folded over the left side of the radiator panel. The large discoloration on the right side of the black chrome solar collector panel is approximately the same shape as the aluminum coating that covered the area in the in-flight photograph. The orientation of the remaining thin-film atomic oxygen experiment patch indicates that the patch is attached to the Dacron mesh and that the attachment is very fragile. The layer of Kapton tape that covered the ends of the thin-film strips appears to have eroded, thus exposing the adhesive. The remaining materials of the atomic oxygen experiment have changed color; most are severely degraded. The silvered Teflon coating of the radiator panel appears diffuse with a light brown discoloration over most of the surface. The white, evenly spaced, discolorations along the horizontal centerline and along the edges of the panel appear to be above countersunk flat head screws used to assemble the experiment. The black spots on the radiator panel appear to be impact craters that penetrated the Teflon material and exposed the silver beneath to atomic oxygen flux. Particles of the degraded thermal blanket material, which appeared to adhere to the surface of the radiator panel in the in-flight photograph, are gone.

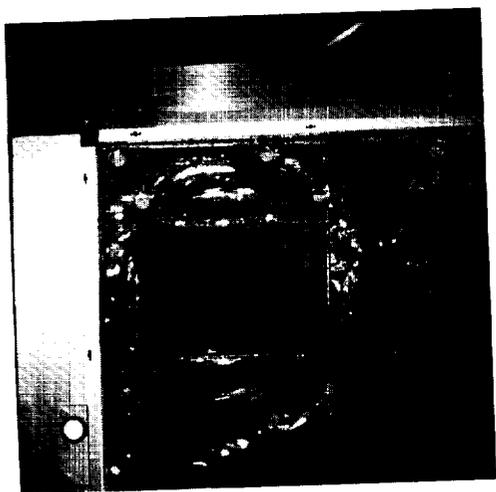
Figure 517
Photo No.: KSC-390C-2157.04
Dup. Neg. No.: L91-11450
LISAR No.: EL-1994-00520
Photo Credit: KSC
Photo Date: 3/21/90
Location: KSC SAEF II
Subject: Postflight Detail of Upper Left of Tray F9

Figure 517 (Postflight). This photograph is of the upper left one-sixth of the tray. The thin coating of vapor-deposited aluminum, left after the Kapton film eroded, is essentially gone and only fragments of the thermal blanket remain. Pieces of Dacron mesh material are visible along the edges of the blanket and near the buttons that were used to secure the blanket. The large area of discoloration on the right side of the black chrome solar collector panel appears to be approximately the same shape as the aluminum coating that covered the area in the in-flight photograph.

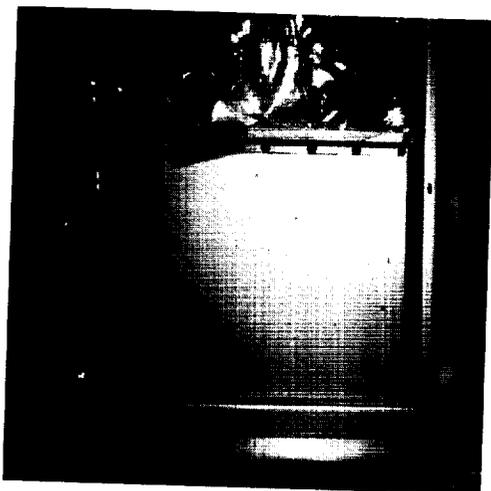
Figure 519
Photo No.: KSC-390C-2157.06
Dup. Neg. No.: L91-11452
LISAR No.: EL-1994-00522
Photo Credit: KSC
Photo Date: 3/21/90
Location: KSC SAEF II
Subject: Postflight Detail of Upper Right of Tray F9

Figure 519 (Postflight). This photograph is of the upper right one-sixth of the tray. The thin coating of vapor-deposited aluminum, left after the Kapton film eroded, is essentially gone and only fragments of the thermal blanket remain. Small discolorations that were caused by impacts are visible on the silvered Teflon film surface of the radiator. Pieces of Dacron mesh are visible. The fragment that covered the left side of the radiator panel has moved to the left.

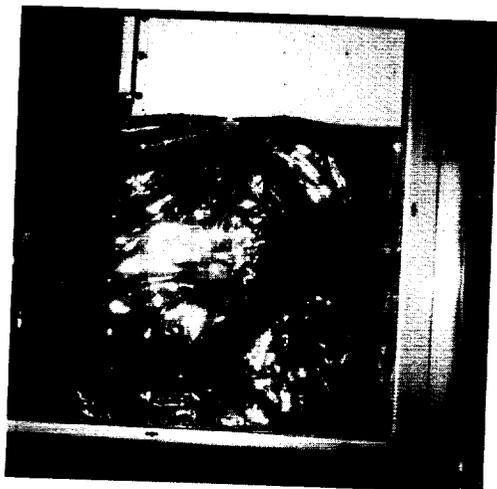
Figure 522
Photo No.: KSC-390C-2157.09
Dup. Neg. No.: L91-11455
LISAR No.: EL-1994-00525
Photo Credit: KSC
Photo Date: 3/21/90
Location: KSC SAEF II
Subject: Postflight Detail of Lower Right of Tray F9

Figure 522 (Postflight). This photograph is of the lower right one-sixth of the tray. The thin coating of vapor-deposited aluminum, which was left after the Kapton film eroded, is essentially gone and only fragments of the thermal blanket remain. Pieces of Dacron mesh are visible along the edges of the blanket and near the buttons that were used to secure the blanket. Note the dark brown discoloration at the edge of the thermal panel at the right.

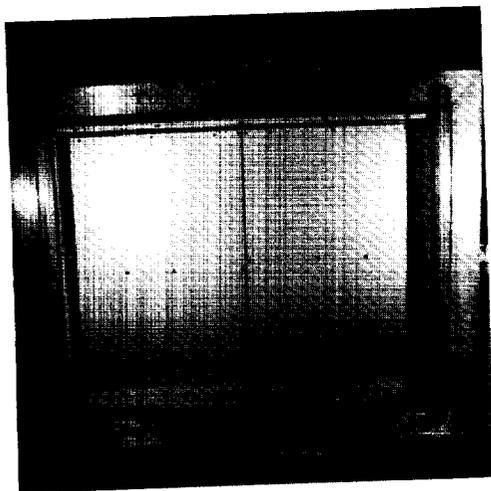
Figure 523 (Postflight). The green tint on the two debris panels is a by-product of the chromic anodize coating process and is not attributed to contamination or exposure to the space environment. A light irregular vertical streak is on the right debris panel. The light band across the top and bottom edges of the panels is caused by light reflecting from the tray sidewalls.

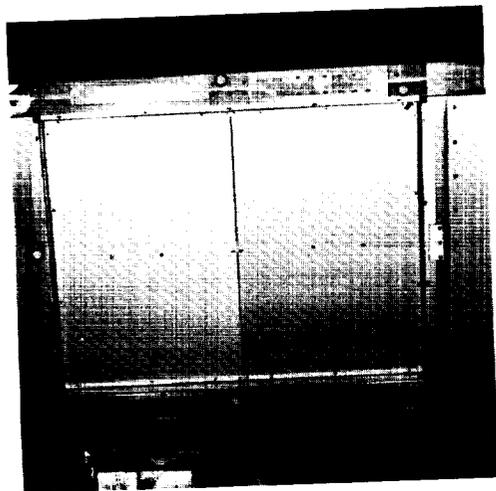
Figure 525
Photo No.: KSC-390C-1028.03
Dup. Neg. No.: L90-13377
LISAR No.: EL-1994-00139
Photo Credit: KSC
Photo Date: 2/9/90
Location: KSC SAEF II
Subject: Postflight Survey of Tray F11

Figure 525 (Postflight). The pink and greenish-gray tints on the two debris panels are by-products of the chromic anodize coating process and are not attributed to contamination or exposure to the space environment. Debris from other experiments that degraded during the mission is visible on the lower experiment tray sidewall at the intersection with the right tray sidewall. A larger piece is located in the upper right corner on the right debris panel. Other experiment debris, which are visible as dark specks, are at the intersection of the debris panel outer edges and the tray sidewalls. The light band along the sides and across the bottom of the panels is caused by light reflecting from the tray sidewalls.

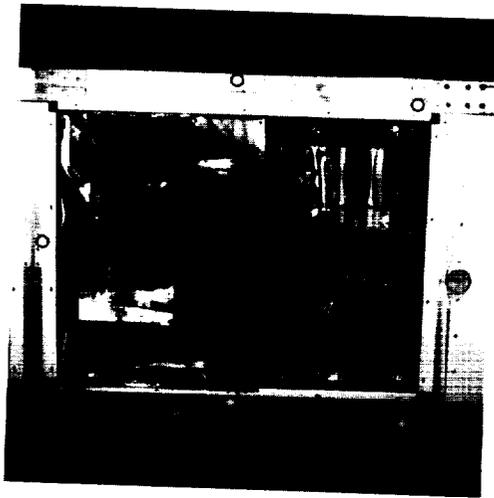
Figure 528
Photo No.: KSC-390C-1069.08
Dup. Neg. No.: L90-13488
LISAR No.: EL-1994-00190
Photo Credit: KSC
Photo Date: 2/8/90
Location: KSC SAEF II
Subject: Postflight Survey of Tray F12

Figure 528 (Postflight). The upper and lower radiator shields have fine vertical marks that may be cracks or abrasions on the surfaces and are discolored by a brown stain. A darker brown stain appears at the intersection of the end shield sections and in the lower left corner where the silvered Teflon tape, which is hanging over the LDEF structure, has pulled away. The area initially covered by the tape appears clean and is outlined by a vertical line of discolored material. The external thermal control blanket has cracks and tears near the intersection with the radiator; it appears more fragile than in the prelaunch photograph. The lower patch of atomic oxygen experiment materials has many severely degraded samples. Several of the materials have sections eroded away and remain attached at only one end. Other materials are completely gone or have only fragments that remain. The materials in the upper patch have survived better, but are eroded, wrinkled, and have distorted shapes. Discolorations that appear to be pieces of Kapton tape lie horizontally across the lower third of the upper patch of materials. Another piece of Kapton tape lies horizontally across the center of the lower patch of material samples.

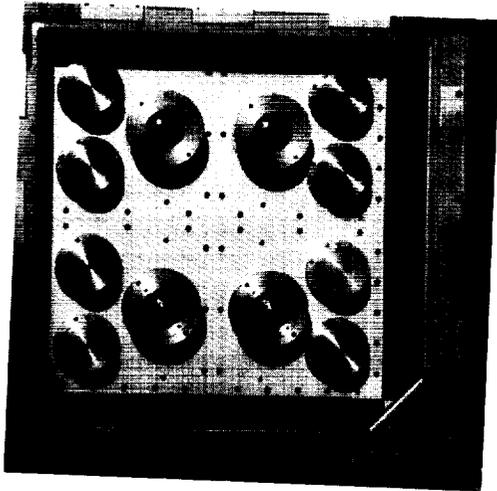
Figure 530
Photo No.: S32-76-068
Dup. Neg. No.: L90-10392
LISAR NO.: EL-1994-00669
Photo Credit: JSC
Photo Date: 1/12/90
Location: In Flight
Subject: In-Flight Survey of Tray G2

Figure 530 (In Flight). The frame structure is discolored in locations that are adjacent to the edge of the black thermal panels. There is a reflection of canisters in the right and lower tray side walls. The Biostack Experiment AO015 appears to have survived with all hardware in place. The exposed Kapton H foil that covered windows in two detector housings is deformed because of positive internal pressure, but remains intact.

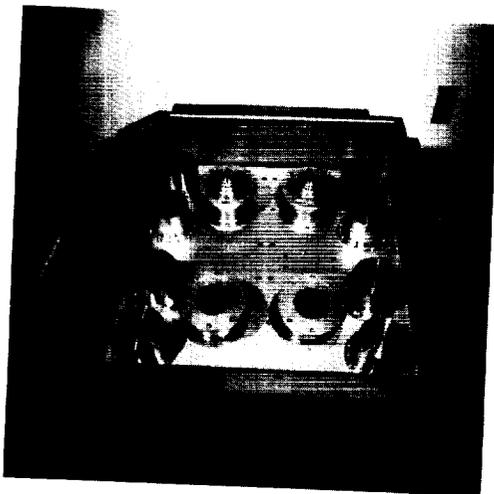
Figure 531
Photo No.: KSC-390C-1938.09
Dup. Neg. No.: L91-11607
LISAR NO.: EL-1994-00282
Photo Credit: KSC
Photo Date: 3/14/90
Location: KSC SAEF II
Subject: Postflight Survey of Tray G2

Figure 531 (Postflight). The experiment appears to have survived the extended mission with no visible damage. The experiment housings are intact and all hardware is securely in place. The detector housings appear to have a stain that is similar to that on the tray hardware. The Kapton H foil that covered windows in two detector housings does not appear to have been damaged during the extended mission. The perforated dome on two of the detector housings has a slight tan discoloration, but there is no indication of damage.

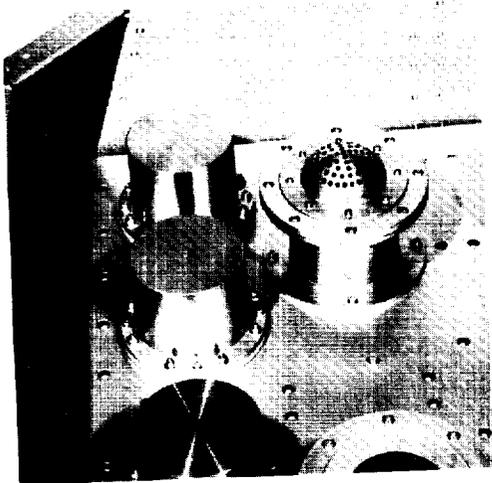
Figure 532
Photo No. KSC-390C-1938.10
Dup. Neg. No.: L91-11608
LISAR NO.: EL-1994-00437
Photo Credit: KSC
Photo Date: 3/14/90
Location: KSC SAEF II
Subject: Postflight Detail of Upper Left of Tray G2

Figure 532 (Postflight). This photograph is of the upper left one-fourth of the tray. The experiment housings are intact and all hardware is securely in place. The detector housings appear to have a light stain.

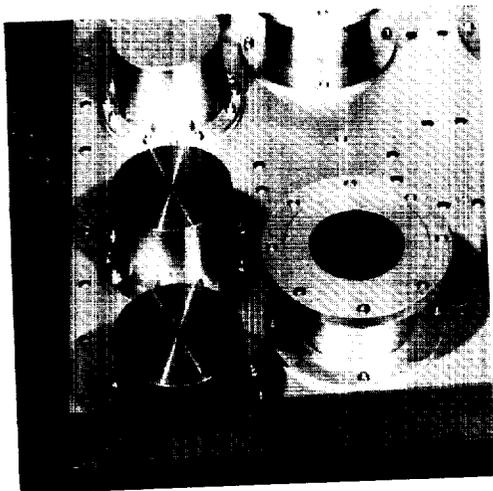
Figure 533
Photo No. KSC-390C-1938.11
Dup. Neg. No.: L91-11609
LISAR NO.: EL-1994-00438
Photo Credit: KSC
Photo Date: 3/14/90
Location: KSC SAEF II
Subject: Postflight Detail of Lower Left of Tray G2

Figure 533 (Postflight). This photograph is of the lower left one-fourth of the tray. The experiment housings are intact and all hardware is securely in place. The detector housings appear to have a light stain.

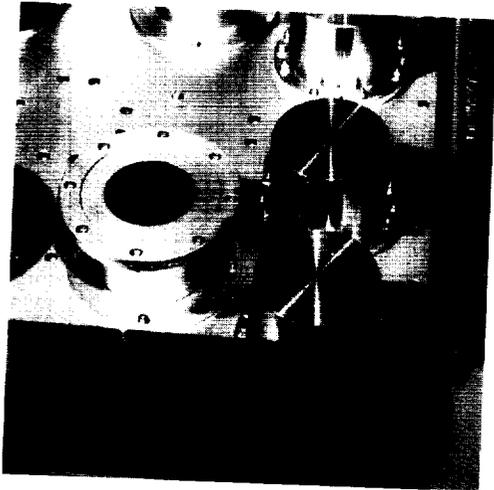
Figure 534
Photo No. KSC-390C-1938.12
Dup. Neg. No.: L91-11610
LISAR NO.: EL-1994-00439
Photo Credit: KSC
Photo Date: 3/14/90
Location: KSC SAEF II
Subject: Postflight Detail of Lower Right of
Tray G2

Figure 534 (Postflight). This photograph is of the lower right one-fourth of the tray. The experiment housings are intact and all hardware is securely in place. The detector housings appear to have a light stain.

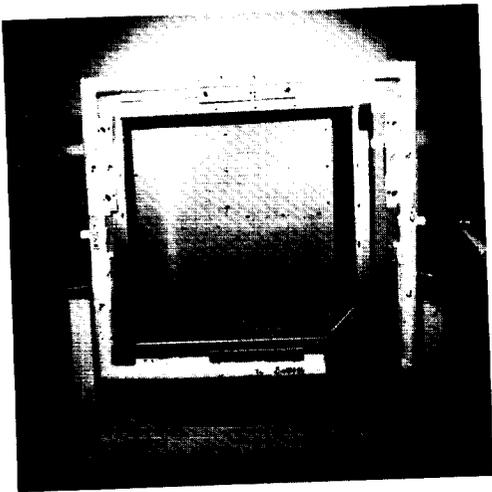
Figure 536 (Postflight). The light pink tint of the debris panel is a by-product of the chromic anodize coating process and is not attributed to contamination or exposure to the space environment. A brown stain is located in the lower right corner of the tray.

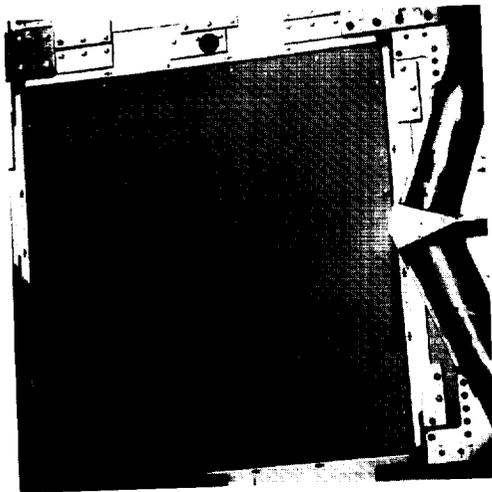
Figure 538
Photo No.: S32-76-066
Dup. Neg. No.: L90-10391
LISAR NO.: EL-1994-00081
Photo Credit: JSC
Photo Date: 1/12/90
Location: In Flight
Subject: In-Flight Survey of Tray G6

Figure 538 (In Flight). The cover plate appears brown because of the lighting. Later photographs indicated that the cover was a slightly discolored white. The narrow band of discolorations at the right, left, and upper edges of the cover plate appears to be areas of masking tape residue that have turned brown.

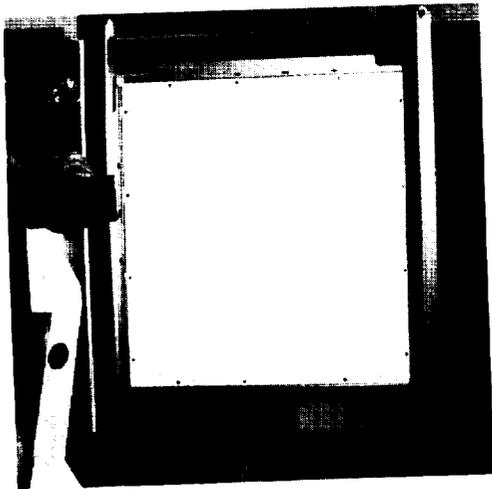
Figure 539
Photo No.: KSC-390C-1704.05
Dup. Neg.: L91-11642
LISAR NO.: EL-1994-00265
Photo Credit: KSC
Photo Date: 3/7/90
Location: KSC SAEF II
Subject: Postflight Survey of Tray G6

Figure 539 (Postflight). Experiment (AO139A) appears to have survived the extended mission with no visible damage. Some discoloration appears near the center of the left flange of the tray. The experiment cover plate, which was originally white, is discolored by a very light brown stain, but it is intact and securely in place.

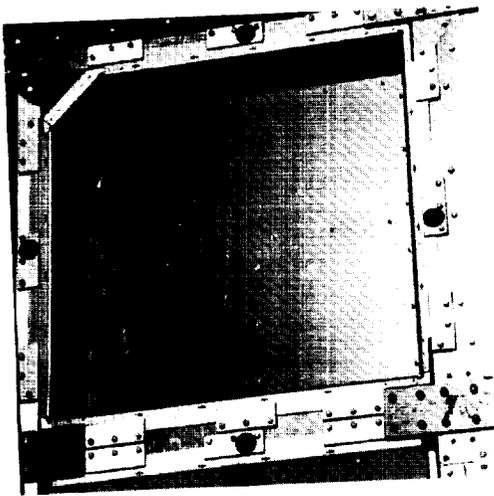
Figure 541 (In Flight). The darkness in the left section of the debris panel is attributed to the lighting, although the panel appears to have a light discoloration. The scrapes and scratch marks are from preflight handling and are not mission related.

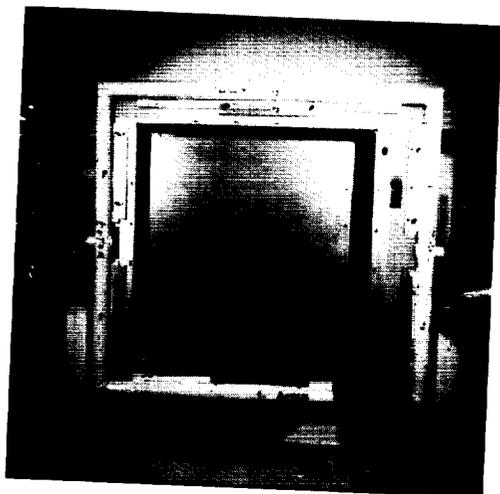
Figure 542
Photo No.: KSC-390C-2308.09
Dup. Neg. No.: L91-11669
LISAR NO.: EL-1994-00313
Photo Credit: KSC
Photo Date: 3/26/90
Location: KSC SAEF II
Subject: Postflight Survey of Tray G8

Figure 542 (Postflight). Irregular tan discolorations are visible on the lower experiment tray sidewall. The pink tint on the debris panel is a by-product of the chromic anodize coating process and is not attributed to contamination or exposure to the space environment. The light spots on the debris panel are the same abrasions that were observed in the in-flight photograph.

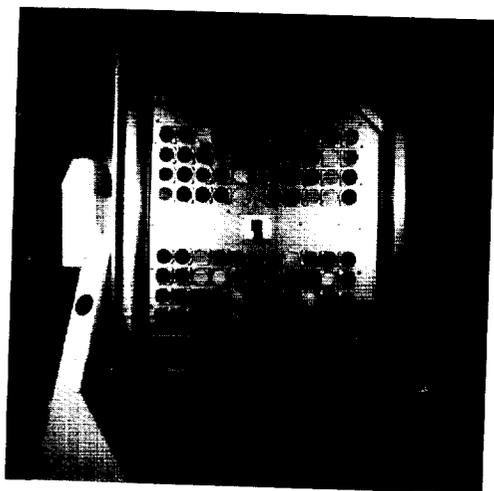
Figure 545
Photo No.: KSC-390C-2068.08
Dup. Neg. No.: L91-11688
LISAR NO.: EL-1994-00298
Photo Credit: KSC
Photo Date: 3/19/90
Location: KSC SAEF II
Subject: Postflight Survey of Tray G10

Figure 545 (Postflight). Experiment AO201 appears to have no visible degradation. The blue in the metallic surface of the detectors is caused by reflections of the surrounding area.

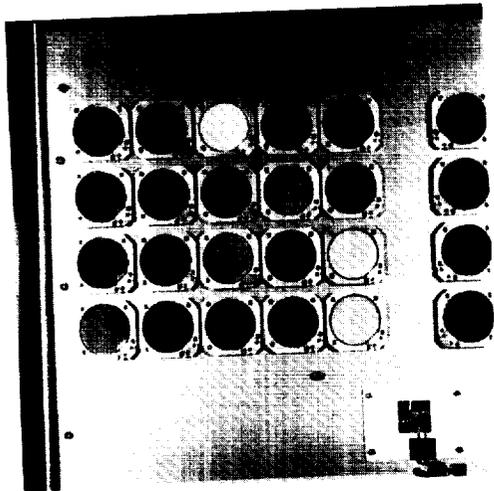
Figure 546
Photo No. KSC-390C-2068.09
Dup. Neg. No.: L91-11689
LISAR NO.: EL-1994-00468
Photo Credit: KSC
Photo Date: 3/19/90
Location: KSC SAEF II
Subject: Postflight Detail of Upper Left of Tray G10

Figure 546 (Postflight). This photograph is of the upper left one-fourth of the tray. The blue on the mirrorlike surface of the detectors is caused by reflections of the surroundings. Small impact craters are visible on some detectors. Surface scratches are also visible on the baseplate.

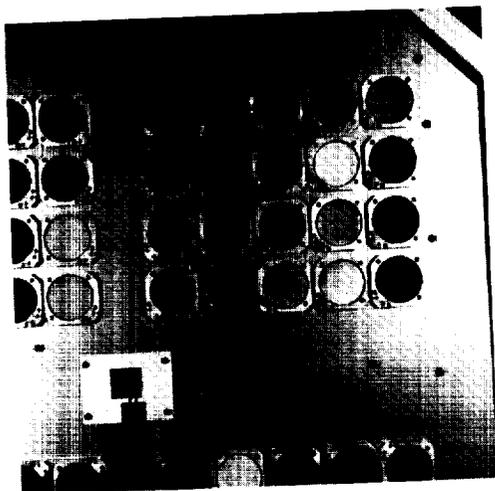
Figure 547
Photo No. KSC-390C-2068.10
Dup. Neg. No.: L91-11690
LISAR NO.: EL-1994-00469
Photo Credit: KSC
Photo Date: 3/19/90
Location: KSC SAEF II
Subject: Postflight Detail of Upper Right of
Tray G10

Figure 547 (Postflight). This photograph is of the upper right one-fourth of the tray. Small impact craters are visible on some detectors. The blue on the mirrorlike surface of the detectors is caused by reflections of the surroundings. Surface scratches are visible on the baseplate.

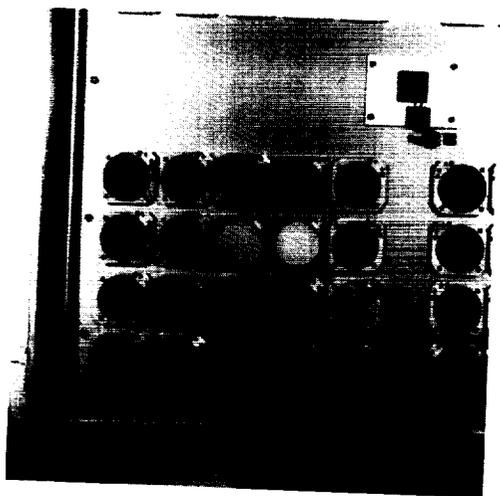
Figure 548
Photo No. KSC-390C-2068.11
Dup. Neg. No.: L91-11691
LISAR NO.: EL-1994-00470
Photo Credit: KSC
Photo Date: 3/19/90
Location: KSC SAEF II
Subject: Postflight Detail of Lower Left of Tray G10

Figure 548 (Postflight). This photograph is of the lower left one-fourth of the tray. The blue on the mirrorlike surface of the detectors is caused by reflections of the surroundings. Small impact craters are visible on some detectors. Surface scratches are also visible on the baseplate. A pie-shaped discoloration is visible on the detector found second from the left and second from the bottom.

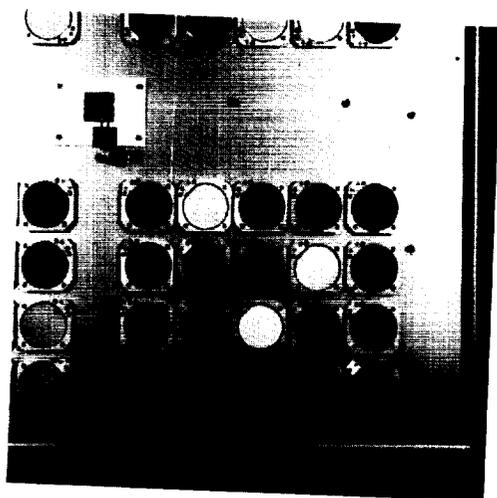
Figure 549
Photo No. KSC-390C-2068.12
Dup. Neg. No.: L91-11692
LISAR NO.: EL-1994-00471
Photo Credit: KSC
Photo Date: 3/19/90
Location: KSC SAEF II
Subject: Postflight Detail of Lower Right of
Tray G10

Figure 549 (Postflight). This photograph is of the lower right one-fourth of the tray. The blue on the mirrorlike surface of the detectors is caused by reflections of the surroundings. Small impact craters are visible on some detectors. Surface scratches are visible on the baseplate.

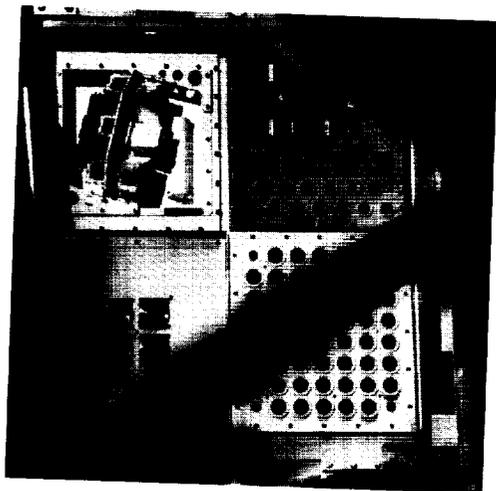
Figure 551
Photo No.: S32-76-054
Dup. Neg. No.: L90-10388
LISAR NO.: EL-1994-00668
Photo Credit: JSC
Photo Date: 1/12/90
Location: In Flight
Subject: In-Flight Survey of Tray G12

Figure 551 (In Flight). Shadows of the remote manipulator system cover a significant area of the picture. A light tan discoloration is visible on the baseplates and the mounting surfaces of the experiments. All experiment hardware appears intact.

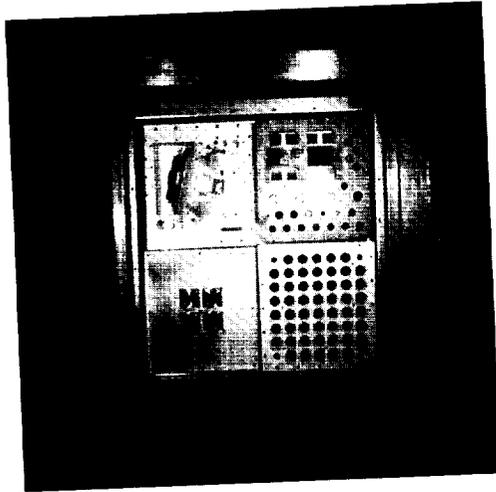
Figure 552
Photo No.: KSC-390C-1997.02
Dup. Neg. No.: L91-11718
LISAR NO.: EL-1994-00296
Photo Credit: KSC
Photo Date: 3/15/90
Location: KSC SAEF II
Subject: Postflight Survey of Tray G12

Figure 552 (Postflight). The experiment hardware appears intact. There are areas of discoloration on the baseplates and mounting structure of the experiments. The cover plate of experiment AO147 in the lower left, which was originally painted with Chemglaze II A276, now has a light tan discoloration over most of the surface area.

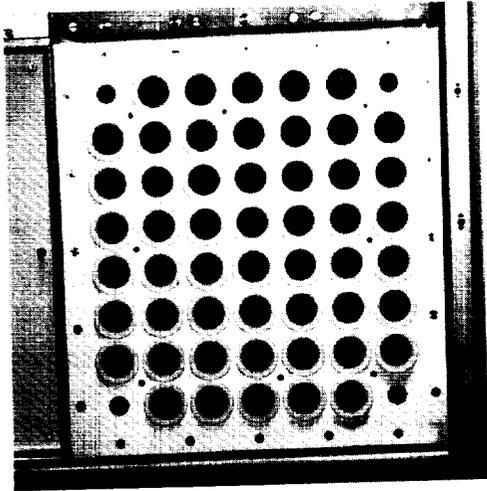
Figure 556
Photo No.: KSC-390C-1997.06
Dup. Neg. No.: L91-11722
LISAR NO.: EL-1994-00445
Photo Credit: KSC
Photo Date: 3/15/90
Location: KSC SAEF II
Subject: Postflight Detail of Lower Right of
Tray G12

Figure 556 (Postflight). This photograph is of the lower right one-fourth of the tray. The faceplate that was painted with Chemglaze II A276 white paint is slightly less white than in preflight. There are brown discoloration flow patterns below some of the sample holders. The test samples are intact.

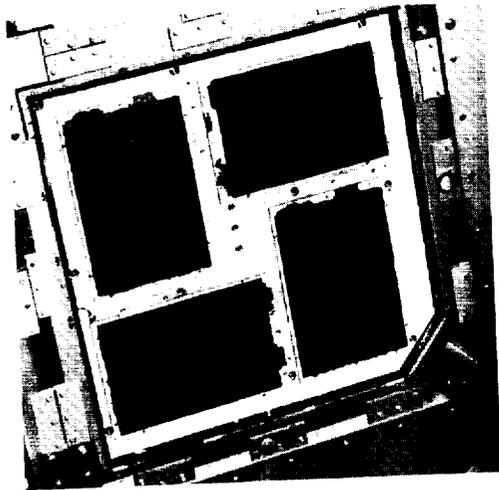
Figure 558
Photo No.: S32-75-036
Dup. Neg. No.: L90-10355
LISAR NO.: EL-1994-00085
Photo Credit: JSC
Photo Date: 1/12/90
Location: In Flight
Subject: In-Flight Survey of Tray H1

Figure 558 (In Flight). The white paint dots on the center clamp blocks of the right flange and lower flange of the experiment tray are discolored. The discoloration diminishes as the distance from the vent area of the thermal panels increases. The right and lower tray flanges near the vents also are discolored. Fingerprints are visible on the thermal panels in the vicinity of the panel mounting fasteners. The experiment hardware appears to be intact with no apparent changes other than stains along outer edges of the solar arrays.

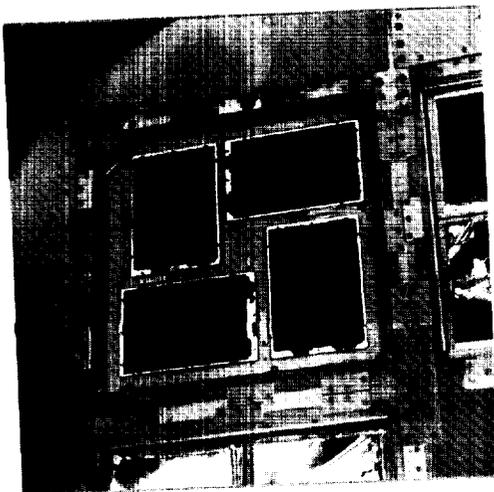
Figure 559
Photo No.: S32-S-282
Dup. Neg. No.: L92-21189
LISAR NO.: EL-1994-00071
Photo Credit: JSC
Photo Date: 1/22/90
Location: Shuttle Cargo Bay at Dryden
Subject: Postflight Survey of Tray H1

Figure 559 (Postflight). This photograph of experiment S1001 was taken from the cargo bay access hatch of the orbiter during postlanding operations at Dryden Flight Research Center. Note the discolorations on the structure of the LDEF, tray flanges, and tray clamp white dots. Note also the variation of discoloration with proximity to the thermal panel vents. Fingerprints are visible on the thermal panels in the vicinity of the panel mounting fasteners. The experiment hardware is intact with no apparent changes other than stains along outer edges of the solar arrays. The atomic oxygen samples in the upper left corner of the tray appear to be degraded. The Kapton tape is loose on the sample in the lower right corner of the tray and on the center sample on the upper tray flange. In other areas, the tape appears to be firmly adhered to the tray flanges.

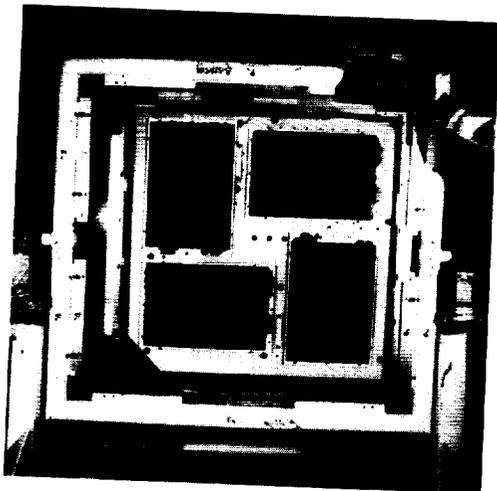
Figure 560
Photo No.: KSC-390C-2367.04
Dup. Neg. No.: L91-11748
LISAR NO.: EL-1994-00315
Photo Credit: KSC
Photo Date: 3/28/90
Location: KSC SAEF II
Subject: Postflight Survey of Tray H1

Figure 560 (Postflight). The experiment hardware is intact with no apparent changes other than stains along outer edges of the solar arrays. The light brown stains observed along the upper edges of the solar array mounting plates and around the outer edge of the baseplate in the in-flight photograph are not apparent in this postflight photograph.

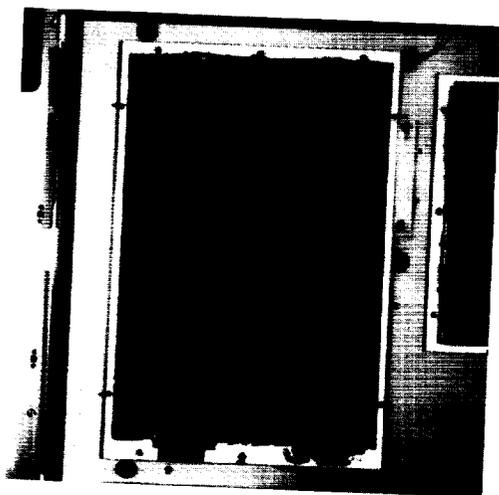
Figure 561
Photo No.: KSC-390C-2367.05
Dup. Neg. No.: L91-11749
LISAR NO.: EL-1994-00622
Photo Credit: KSC
Photo Date: 3/28/90
Location: KSC SAEF II
Subject: Postflight Detail of Upper Left of Tray H1

Figure 561 (Postflight). This photograph is of the upper left one-fourth of the tray. The solar cells appear intact. A few small impact craters on the array are visible. The atomic oxygen experiment samples that were attached to the tray flanges with Kapton tape are in place.

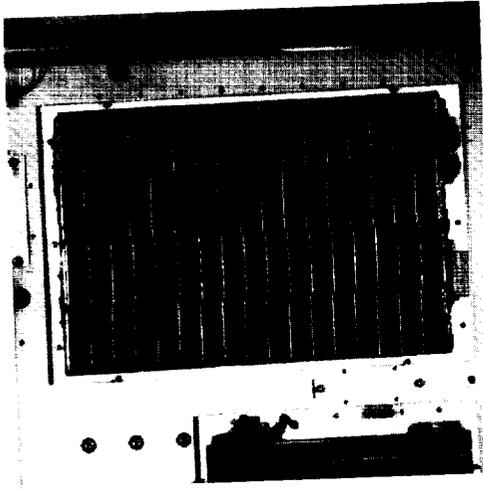
Figure 562
Photo No.: KSC-390C-2367.06
Dup. Neg. No.: L91-11750
LISAR NO.: EL-1994-00623
Photo Credit: KSC
Photo Date: 3/28/90
Location: KSC SAEF II
Subject: Postflight Detail of Upper Right of Tray H1

Figure 562 (Postflight). This photograph is of the upper right one-fourth of the tray. The solar cells appear intact. A few small impact craters on the array are visible. The Kapton tape that is holding atomic oxygen experiment samples to the tray flange is loose.

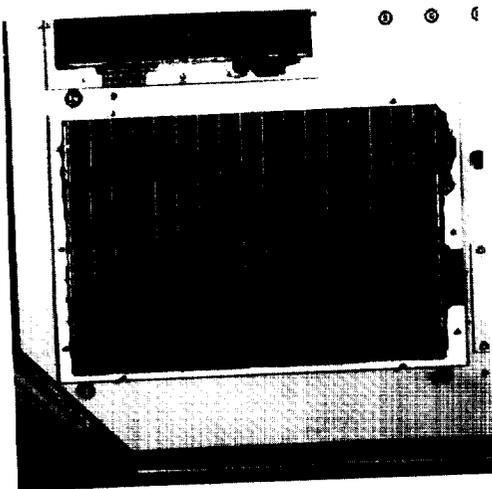
Figure 563
Photo No.: KSC-390C-2367.07
Dup. Neg. No.: L91-11751
LISAR NO.: EL-1994-00618
Photo Credit: KSC
Photo Date: 3/28/90
Location: KSC SAEF II
Subject: Postflight Detail of Lower Left of Tray H1

Figure 563 (Postflight). This photograph is of the lower left one-fourth of the tray. The solar cells appear intact. A few small impact craters on the array are visible. The atomic oxygen experiment samples on the left and in the center that were attached to the tray flanges with Kapton tape are damaged.

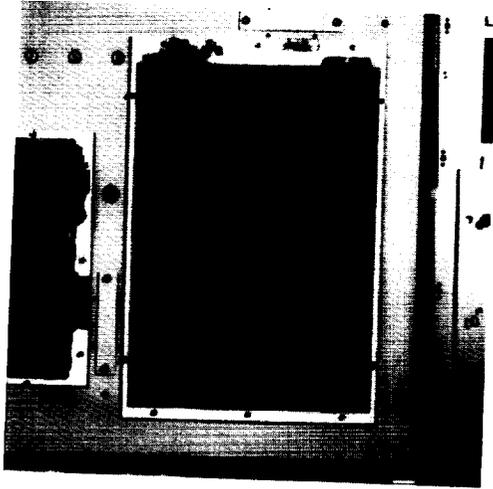
Figure 564
Photo No.: KSC-390C-2367.08
Dup. Neg. No.: L91-11752
LISAR NO.: EL-1994-00624
Photo Credit: KSC
Photo Date: 3/28/90
Location: KSC SAEF II
Subject: Postflight Detail of Lower Right of
Tray H1

Figure 564 (Postflight). This photograph is of the lower right one-fourth of the tray. The solar cells appear intact. A few small impact craters on the array are visible. The atomic oxygen experiment samples attached to the tray flanges with Kapton tape are in place.

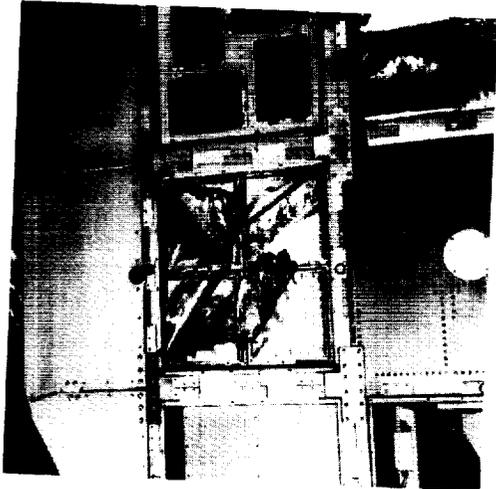
Figure 566
Photo No.: S32-75-043
Dup. Neg. No.: L90-10356
LISAR NO.: EL-1994-00670
Photo Credit: JSC
Photo Date: 1/12/90
Location: In Flight
Subject: In-Flight Survey of Tray H3

Figure 566 (In Flight). A light tan stain is visible on the end structure along the left edge of the tray flange. Lighter stains are also visible on the tray flange between the top and the center tray clamp blocks on the left side. The multilayer thermal insulation blanket has extensive damage. The tape joints have failed along two sides of each experiment module and have allowed the thermal blanket to curl back over itself. The gold-colored surfaces that have then been exposed are the top sheet of the Lexan detector stacks that are held securely in place by the Z shaped aluminum structure.

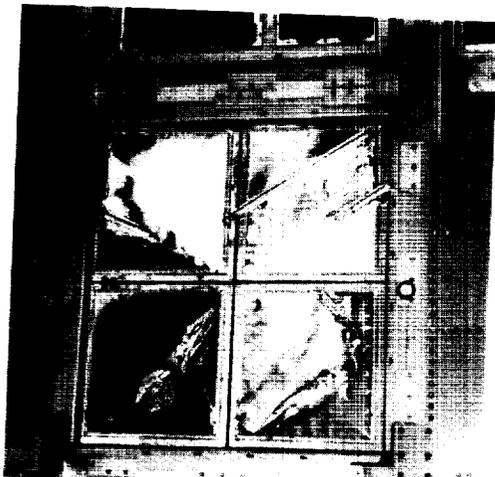
Figure 567
Photo No.: S32-S-278
Dup. Neg. No.: L92-21185
LISAR NO.: EL-1994-00070
Photo Credit: JSC
Photo Date: 1/22/90
Location: Shuttle Cargo Bay at Dryden
Subject: Postflight Survey of Tray H3

Figure 567 (Postflight). This photograph, which was taken from the cargo bay access hatch of the orbiter during postlanding operations at the Dryden Flight Research Center, shows extensive damage to the multilayer thermal insulation blanket. The tape joints appear to have failed along two sides of each experiment module and allowed the multilayer thermal insulation blanket to curl back over itself. The curls are now tighter than they were in flight. Note the discolorations on the structure of the LDEF, tray flanges, and tray clamp white dots and the variation of discoloration with proximity to the thermal panel vents. The paint on the top layer of the thermal blankets, which was originally white, now appears brown or light tan. The fragments of aluminum in the lower two quadrants appear to be from the delamination of the vapor-deposited aluminum from the thermal insulation blanket.

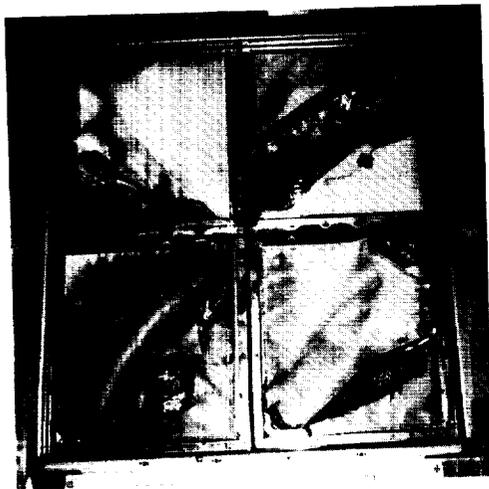
Figure 568
 Photo No.: L90-01797
 Dup. Neg. No.: None
 LISAR NO.: EL-1994-00316
 Photo Credit: LaRC
 Photo Date: 2/6/90
 Location: KSC SAEF II
 Subject: Postflight Survey of Tray H3

Figure 568 (Postflight). This photograph shows the four experiment modules with the thermal blankets severely degraded. The paint on the top layer of the thermal blanket, previously white, is now a glossy tan or soft brown. The tape that was used to attach the thermal blanket to the module frames failed during flight. The tape failed in tension because of thermal shrinkage of the blankets, thus leaving tape on both the frame and the top layer of the thermal blanket. The material exposed underneath the thermal blanket is the top sheet of the detector stack. A Dacron mesh (bridal veil) separator is clearly visible in the upper right module. The coating of vapor-deposited aluminum has delaminated from the Mylar film and the Mylar film has eroded. The delaminated aluminum extends from the blanket in the lower right module. The loss of the Dacron mesh and some of the aluminum delamination is thought to have occurred prior to retrieval; however, a significant portion of the aluminum delamination from the Mylar is thought to have occurred postlanding because of the velocity and direction of air from the cargo bay purge system.

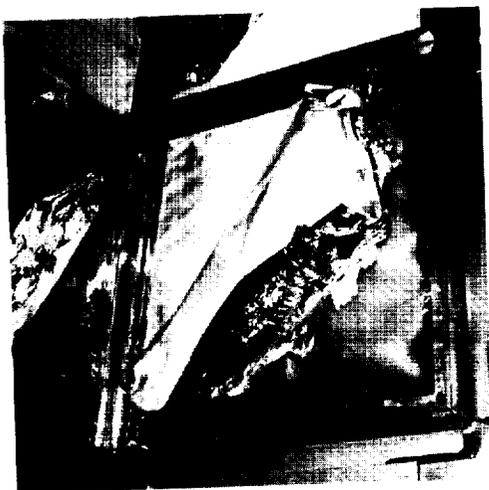
Figure 569
 Photo No.: KSC-390C-828.01
 Dup. Neg. No.: L91-15544
 LISAR NO.: EL-1994-00068
 Photo Credit: KSC
 Photo Date: 2/6/90
 Location: KSC SAEF II
 Subject: Postflight Detail of Lower Right Module of
 Tray H3

Figure 569 (Postflight). This photograph of the lower right module shows the discolorations and the extensive damage to the thermal blanket.

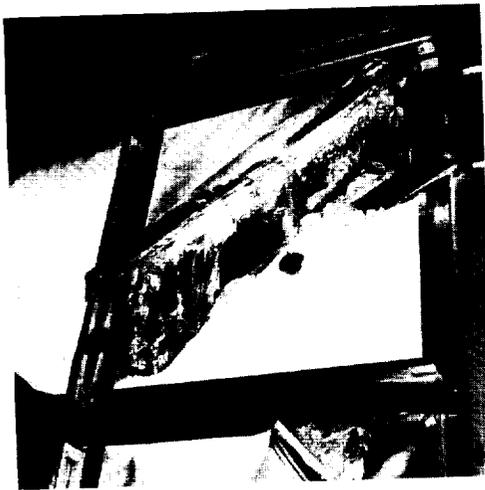
Figure 572
Photo No.: KSC-390C-828.04
Dup. Neg. No.: L91-15547
LISAR NO.: EL-1994-00176
Photo Credit: KSC
Photo Date: 2/6/90
Location: KSC SAEF II
Subject: Postflight Detail of Upper Right Module of
Tray H3

Figure 572 (Postflight). This photograph of the upper right module shows the discolorations and the extensive damage to the thermal blanket.
